MISCELLANEOUS PAPER GL-91-20

INVESTIGATION OF AIRFIELD PAVEMENT FAILURE AT CAIRO EAST AIR BASE

September 1991

Final Report

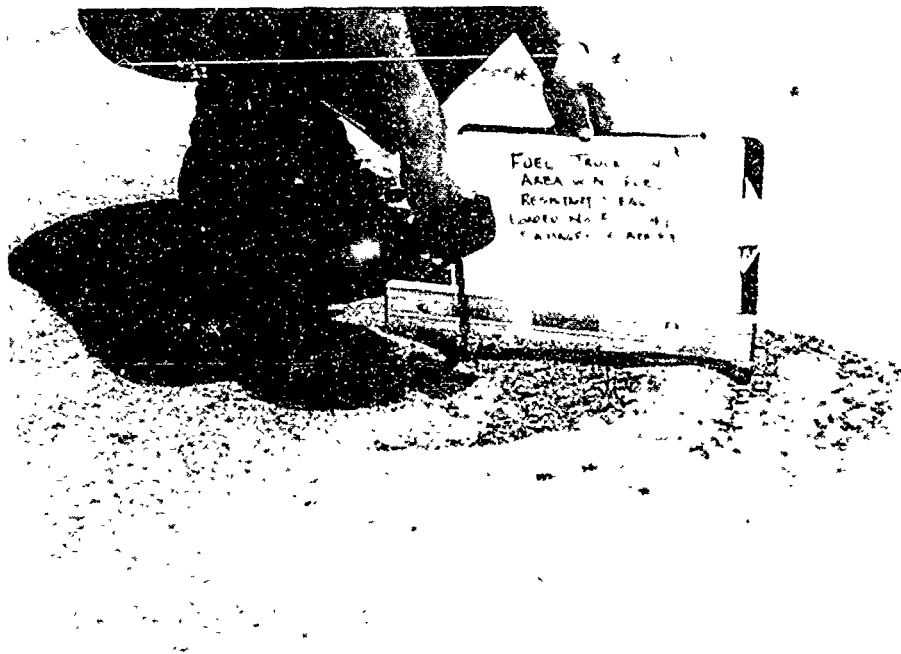
Figure 3. Pavement distress caused by fuel truck

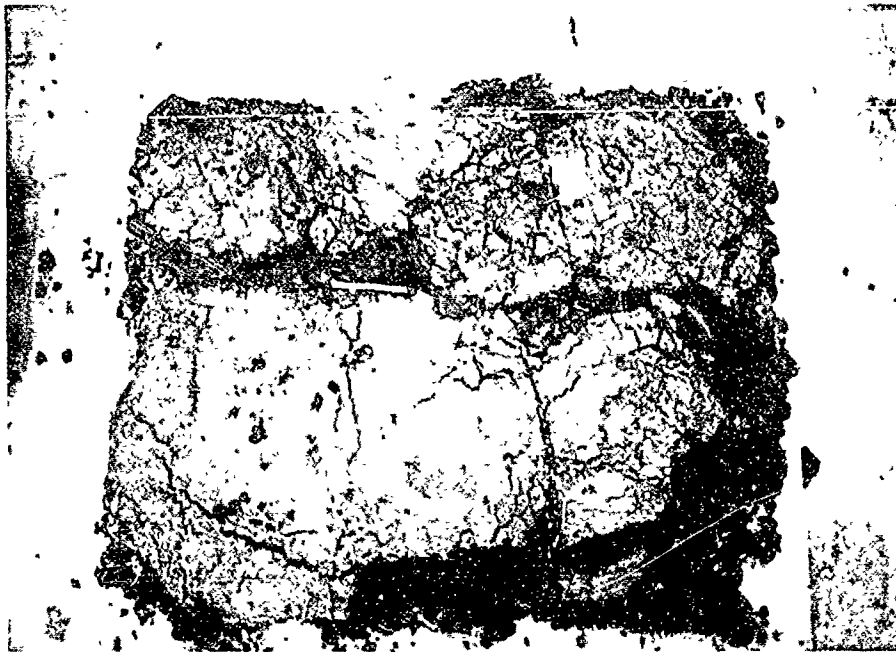
4. In June 1989, four slab samples of asphalt concrete from Cairo East Air Base were received at WES. These four samples were approximately 2 ft* by 2 ft in size and varied in thickness from 4.5 to 6.5 in. Each pavement sample consisted of a surface course layer, an intermediate course layer, and a single-bituminous surface treatment. Two pavement samples (S-3 and S-4) had a fuel-resistant sealer coating on the surface course layer. Figures 5 through 8 show the condition of the slabs at the time of arrival at WES.

Figure 5. Sample S-1, tire print from fifth C-141

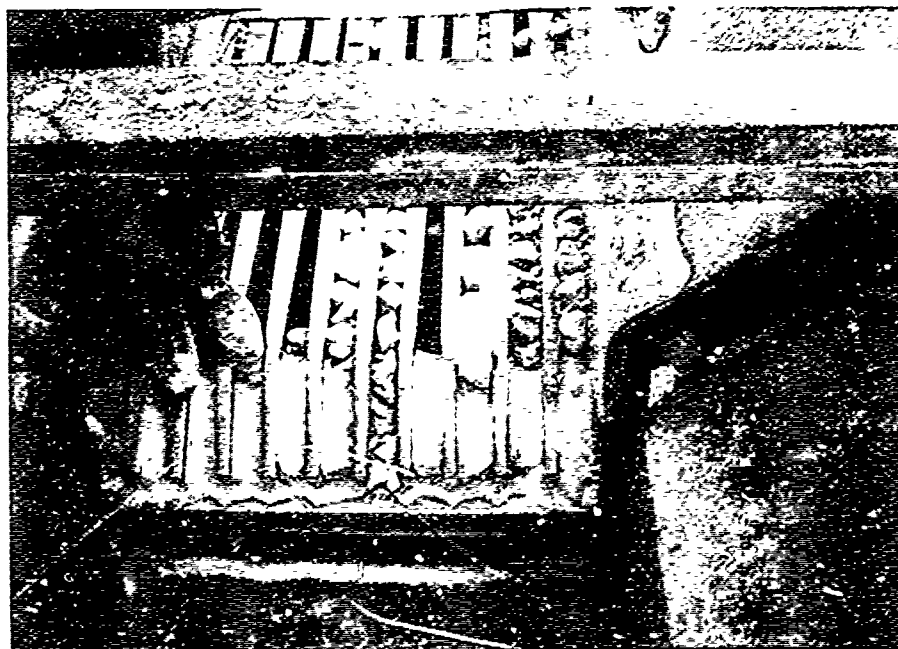
20. The aggregate quarry site was visited to observe the crushing operation. The material being crushed was similar to a pit-run gravel that was excavated from the existing terrain by a front-end loader. The size of the unprocessed material ranged from small boulders to fine aggregates. Approximately 50 percent of the material being processed was estimated to be minus No. 4 material, natural sand. A typical load of material that was processed and crushed is shown in Figure 17. Located at the beginning of the crushing operation was a grizzly, a device designed to discard all material smaller than 3 in. The grizzly was not functioning properly because it was partially blocked (Figure 18), and the feed rate was too high for this short 6-ft grizzly. Both of these problems allowed uncrushed minus 3-in. material to pass through the crushing operation without being fractured. All stockpiles contained uncrushed particles. A typical example of uncrushed particles in the aggregate stockpiles is shown in Figure 19. It was estimated that between 20 and 40 percent of the material being processed was smaller than the No. 4 sieve and was not crushed. It was suggested that the minus No. 4 material be removed from the aggregate prior to crushing to ensure that natural sand and uncrushed materials were not contaminating the crushed stockpile. This could be accomplished by screening the material prior to placing it in the jaw crusher or ensuring that the grizzly functioned properly.

Figure 18. Partially blocked grizzly

- c. Asphalt concrete pavements should not be constructed if substandard materials and mix designs are to be used.
- d. The operations at the aggregate quarry and asphalt plant should be modified to meet standard construction practices.

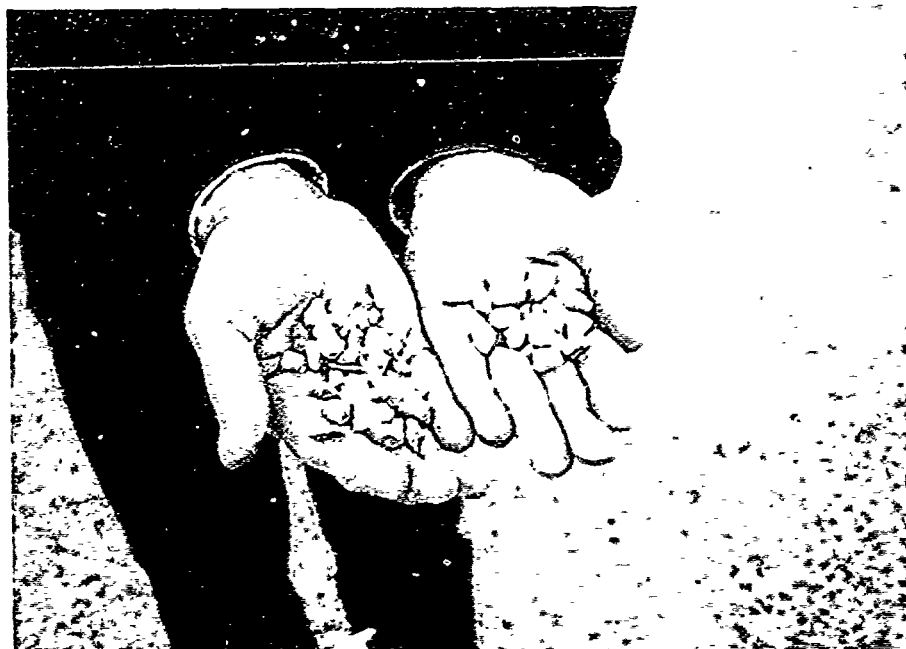
Figure 19. Example of uncrushed particles in aggregate stockpiles
